Results of RFQ "fixes"

C.Y. Tan, J. Schmidt, B. Koubek, D. Bollinger, P. Karns, R. Tomlin 16 May 2012

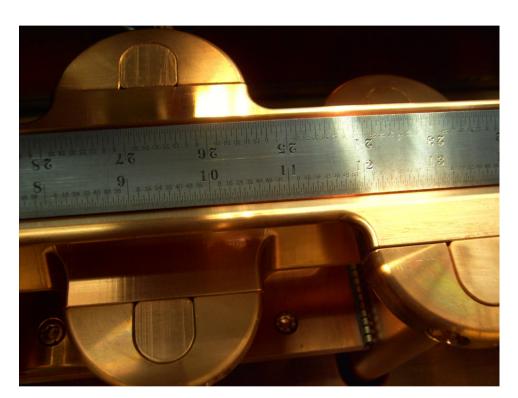
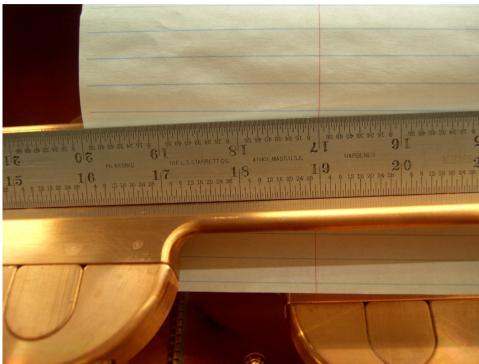
Reduced gap size by $\sim 50\%$ for both horz and vert rods that are visible by changing how much we screwed in the bolts of the stands.

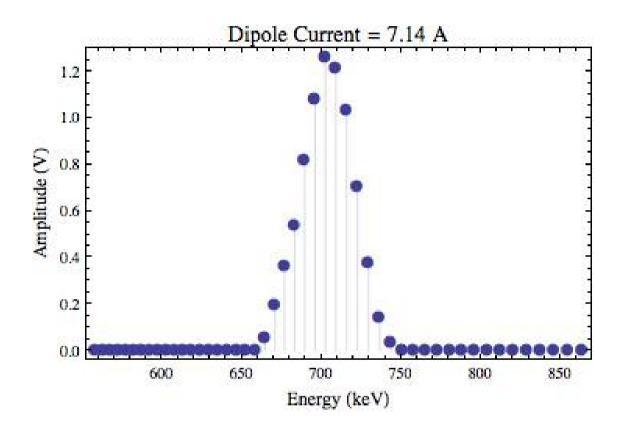
No Change in Energy!

702 keV @ 165 kW

Why????? I would have expected an energy change from my back of the envelope calculation. However, the calculation is for pencil beam and perhaps the effect is smaller because the beam fills the entire aperture? Needs further investigation.

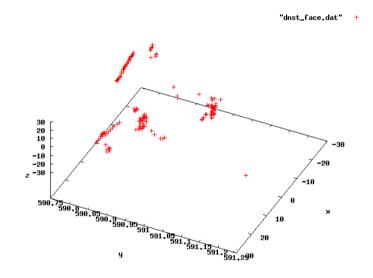
Longitudinally misaligned rods

~0.25 mm misalignment

- Straightened the stands by evenly tightening the bolts of the stands.
- Rods are straight and longitudinally aligned.
- Only one of the rods have dowel pins used to hold to the stands. Other 3 rods do not have dowel pins.

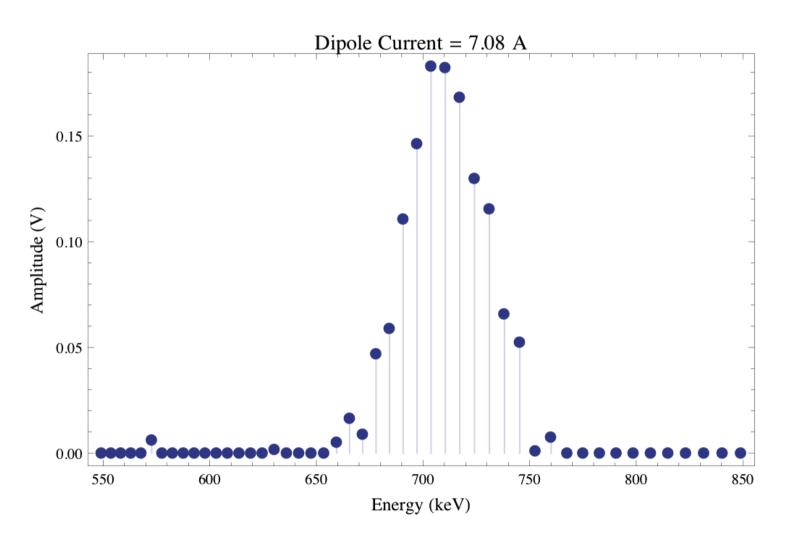
Energy increased by ~10 keV

712 keV @ 169 kW
